**NASA TECHNICAL
MEMORANDUM**

NASA TM X- 62,471

**FIRE SAFETY EVALUATION OF AIRCRAFT LAVATORY AND
CARGO COMPARTMENTS**

August 1975

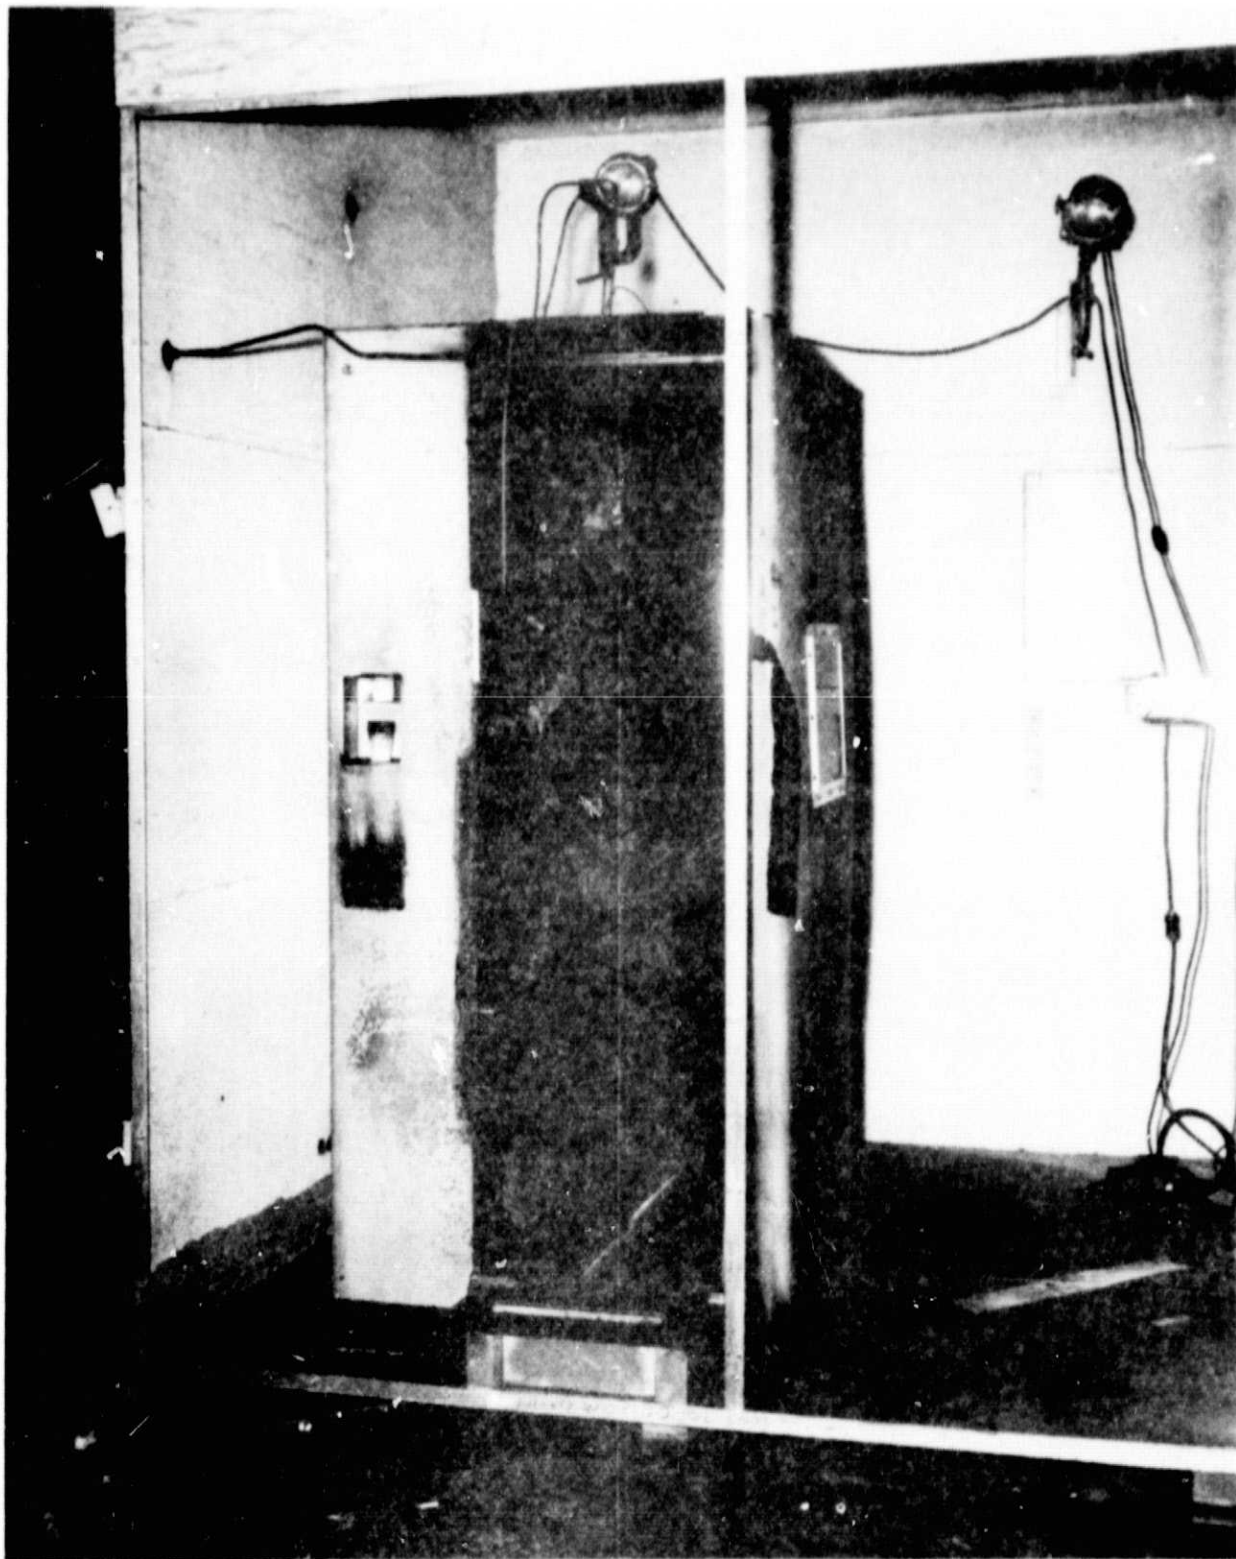
Figure 21.—Lavatory after the test.

Figure 21 is an overall view of the lavatory after the test. All the interior cabinet sandwich panels were charred and delaminated. None of the lavatory walls nor the ceiling were penetrated by flames. The wall opposite the cabinet was distorted and bowed outward. A small area of resin on the outside wall of the waste compartment was scorched. The bifold lavatory door suffered the most damage, delaminating and distorting. It cannot be determined how the observation windows cut in this door may have affected the extent of the damage.

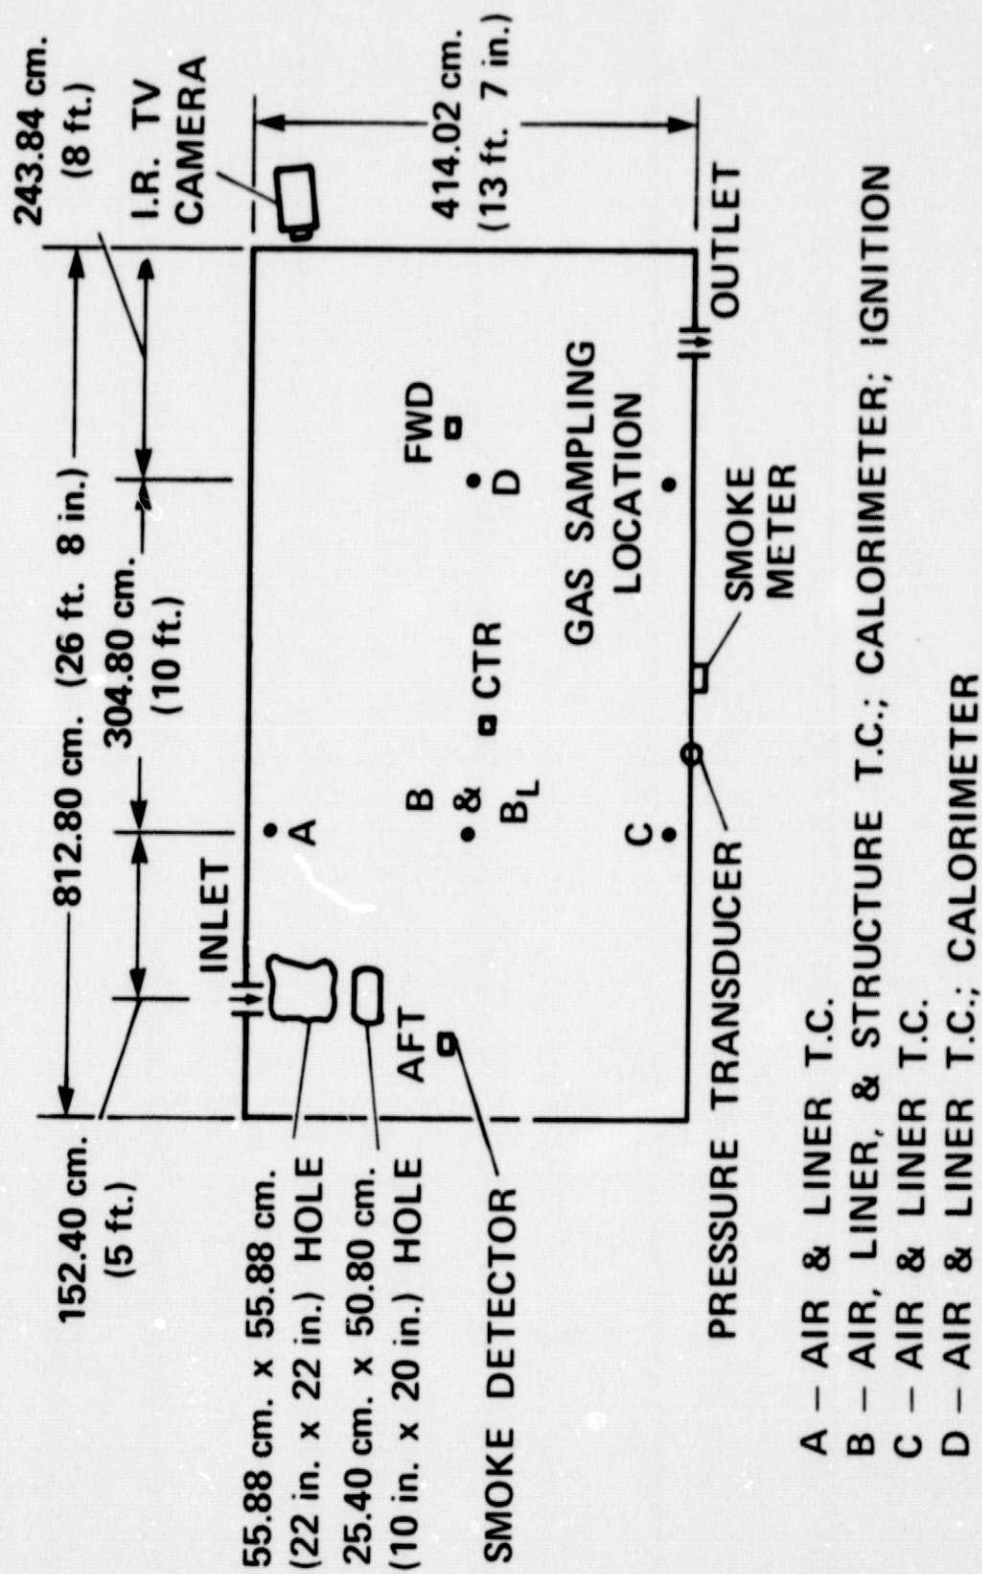
Figure 23.—Instrumentation location in compartment.

Post-test examination revealed two holes burned through the ceiling liner adjacent to the vent inlet. The holes were approximately 55.8 cm x 55.8 cm (22 in. x 22 in.) and 25.4 cm x 50.8 cm (10 in. x 20 in.) as shown in figure 23. Though extensive areas of the ceiling and sidewall liner were delaminated and baked free of resin, no other burn-throughs occurred. Burn-through of the liner constitutes failure of the cargo compartment. Fire damage caused to the cargo liner is shown in figure 30.
